AN INVESTIGATION
OF THE ENGINEERING PROPERTIES
OF THREE PROBLEM EARTH MATERIALS

STUDY NO. 79-1

MISSOURI HIGHWAY AND TRANSPORTATION DEPARTMENT

Final Report

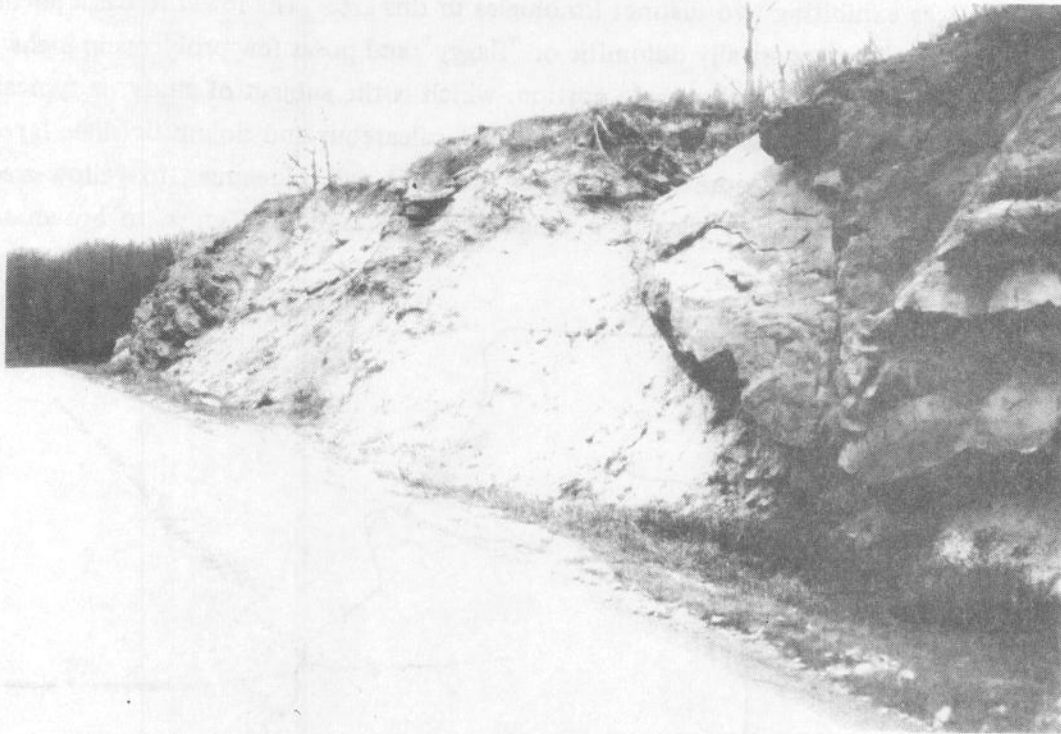
Figure 3. Cheltenham claystones in filled sink deposit on Rte. 50 in Gasconade County. (Note sandstone "rimrock" in foreground).

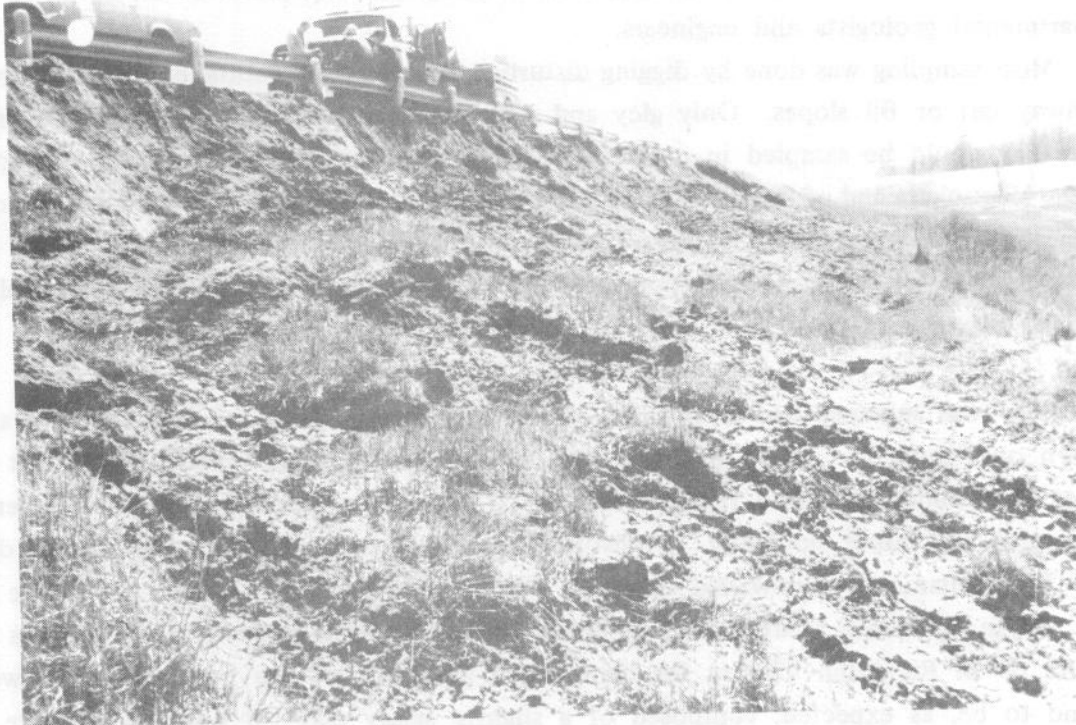
Fill slope failures typically resulted in undermining of the guard rail with slumping extending into the shoulder. Repairs were initiated before such failures could affect the pavement. However, some gley-related failures are so extensive as to be beyond the capacity of maintenance forces to repair and either have been or will be repaired by contract. A typical fill slide involving gley is shown in Figure 5. This is from Route 63 in Randolph County,

Figure 5. Progressive slope failure of fill built partially of gley on Rte. 63, Randolph County.

For repair of slides on existing roadways, the limitations of the existing right-of-way will rarely permit flattening of gley slopes to the required degree. Excavation of the disturbed gley even over-excavation to a temporarily steep slope, followed by replacement with selected material to provide load restraint, is ordinarily the most economical and rapid repair. Depending on the presence of perched water tables and seepage, chimney and blanket drains may also be required. Needless to say, each slide correction requires individual analysis with solutions tailored to individual circumstances.

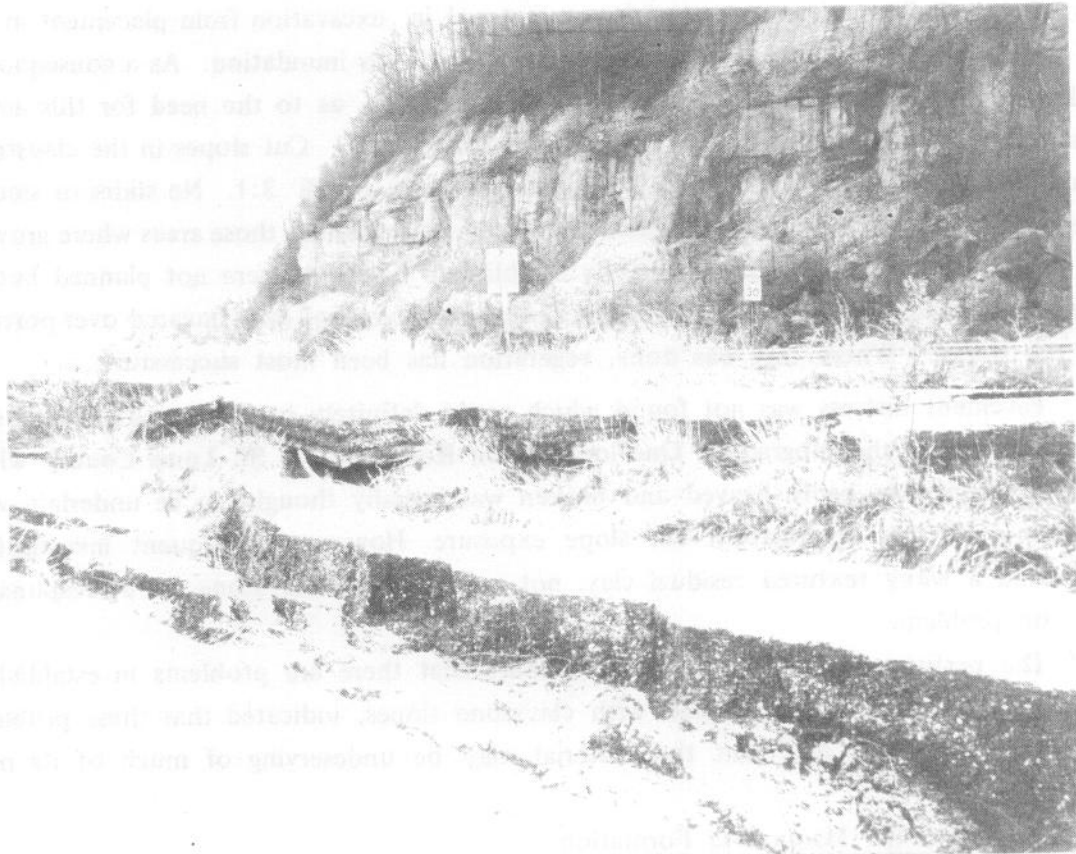
Figure 6. Abandoned Rte. 79 at Clarksville. (Roadway was relocated after green-type failures involving Maquoketa shale).

over Maquoketa talus, has been a severe maintenance problem for years. Extensive creep type movements and sliding resulted locally in a buildup of several feet of asphaltic

Extensive and detailed investigations have shown that the problems at Clarksville are due not only to the presence of Maquoketa clay shales but are compounded by the sidehill location and by seepage percolating downward through the overlying carbonates and accumulating on the more impermeable shale. Such seepage leads to swelling and softening of the shale exposures and contributes to saturation of the embankment and the shale talus which forms the embankment foundation.
