MISSOURI COOPERATIVE HIGHWAY RESEARCH PROGRAM
FINAL REPORT

74-1

**DEVELOPMENT OF DESIGN CRITERIA
FOR CUT SLOPES IN LOESS**

MISSOURI STATE HIGHWAY DEPARTMENT

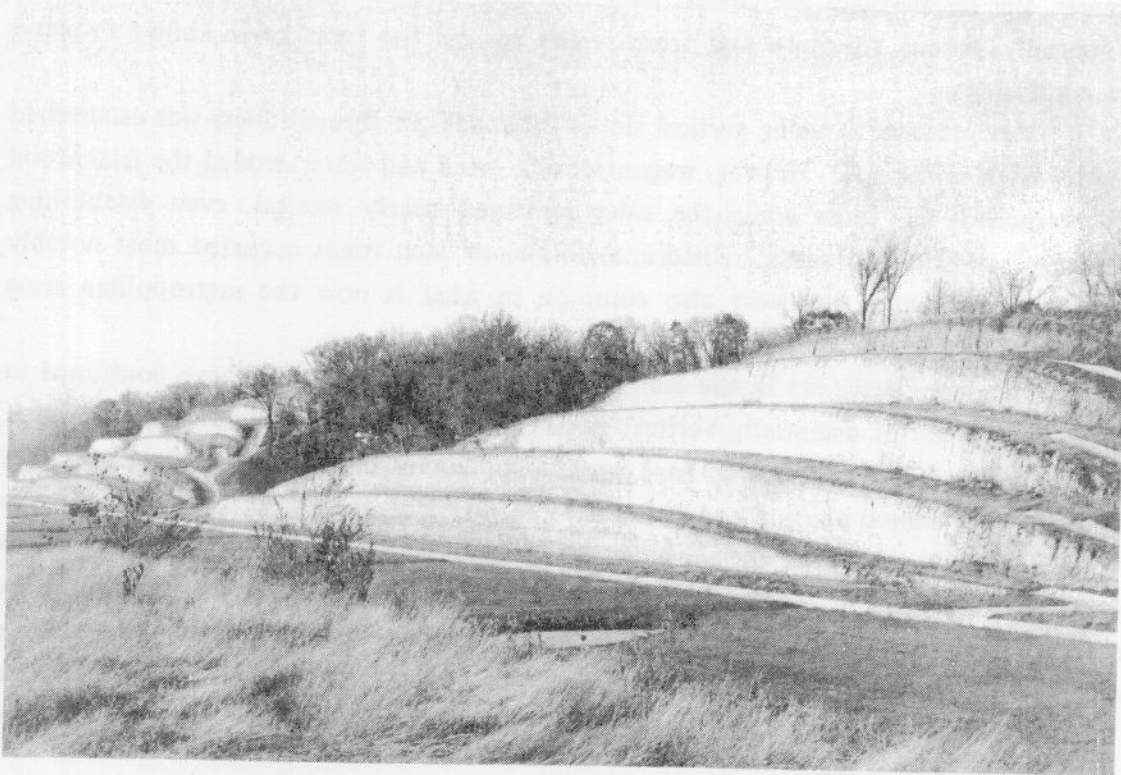
Figure 1. Example of successful use of near vertical rises with benches (stepped slope) (Buchanan County, I-229)

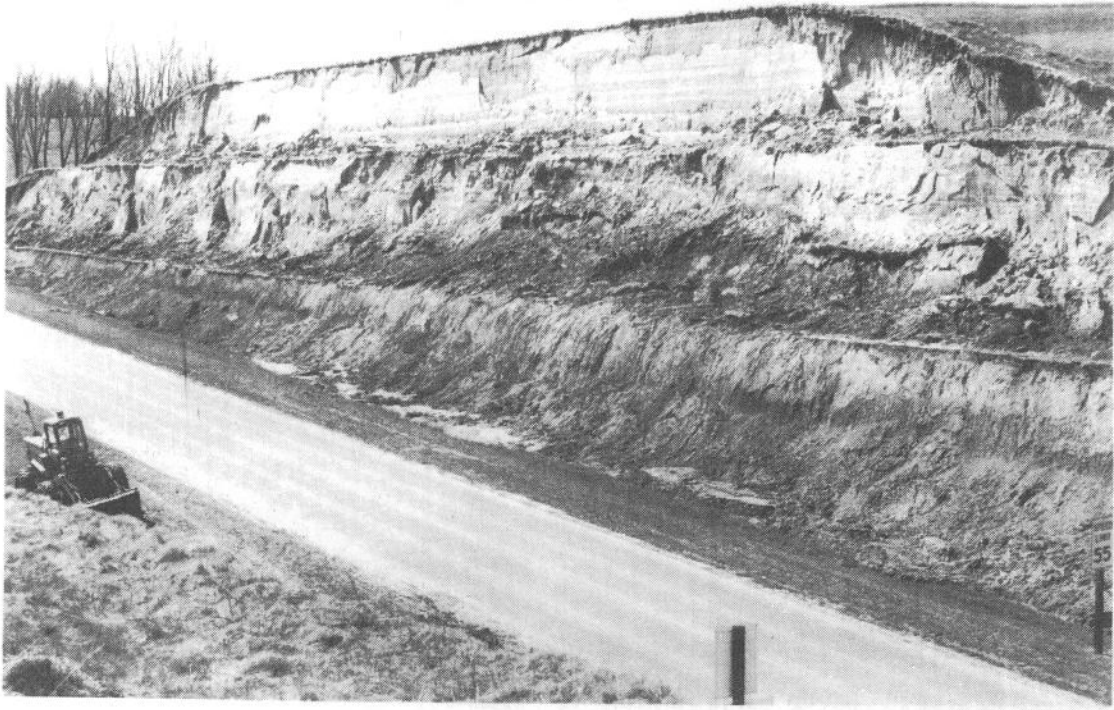
Figure 2. Example of a stepped slope which has failed
(Howard County, Route D(87))

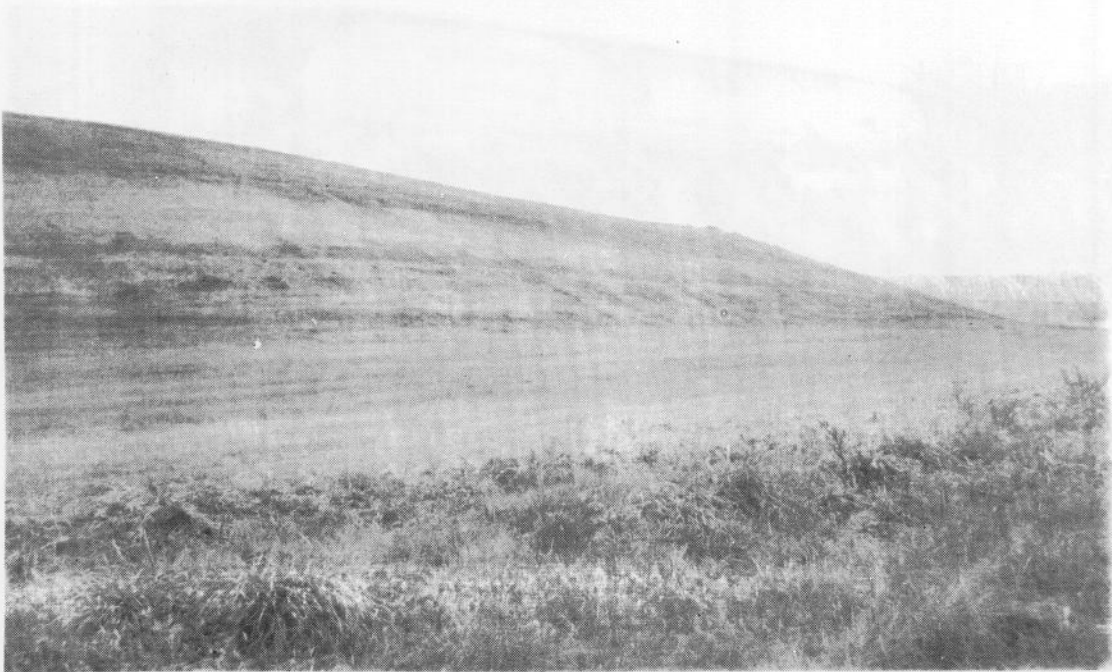
Figure 3. Example of a flattened slope ($2\frac{1}{2}$ on 1) performing adequately in highly erosive loess. (Howard County, Route D(87))

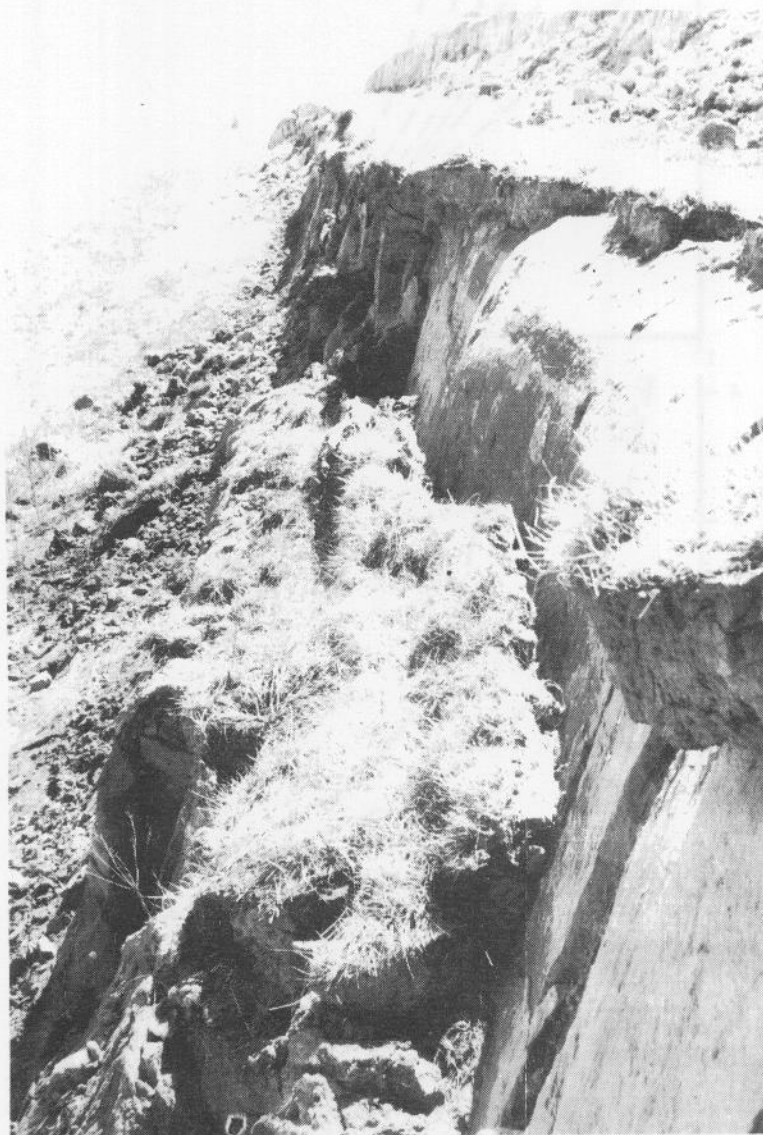
A fourth requirement, unique to loess slopes, is that the slope be steep enough to fail after the ice lense melts. Ice lense development was found to occur approximately 18 to 24 inches behind the face and, to a lesser extent, below the bench above a vertical slope. With thawing, failure occurs along the ice plane with liquefaction of the soil usually apparent after failure. An example of this type of failure is illustrated in Figure 8.

Figure 8. Freeze damage to a north facing stepped slope (Holt County, Route I-29)

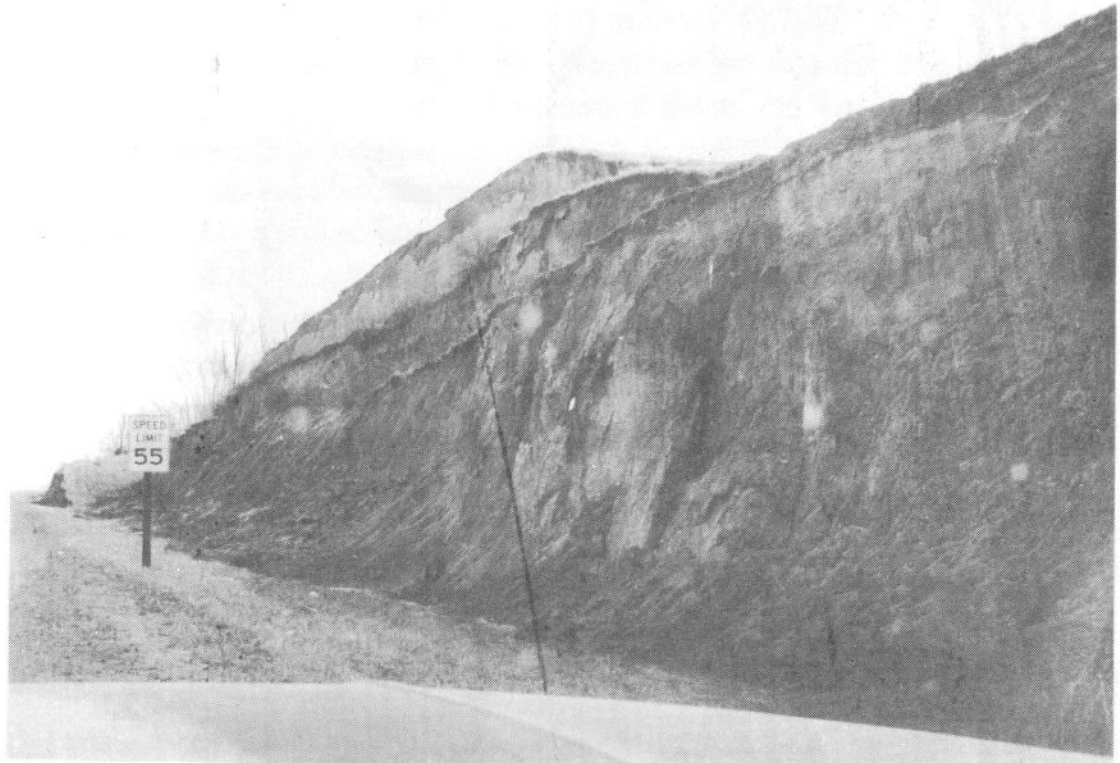
Figure 9. Slides and heavy frost damage due to truncation of a water table at the level of the second bench in northeast facing cut (Howard County, Route D(87))

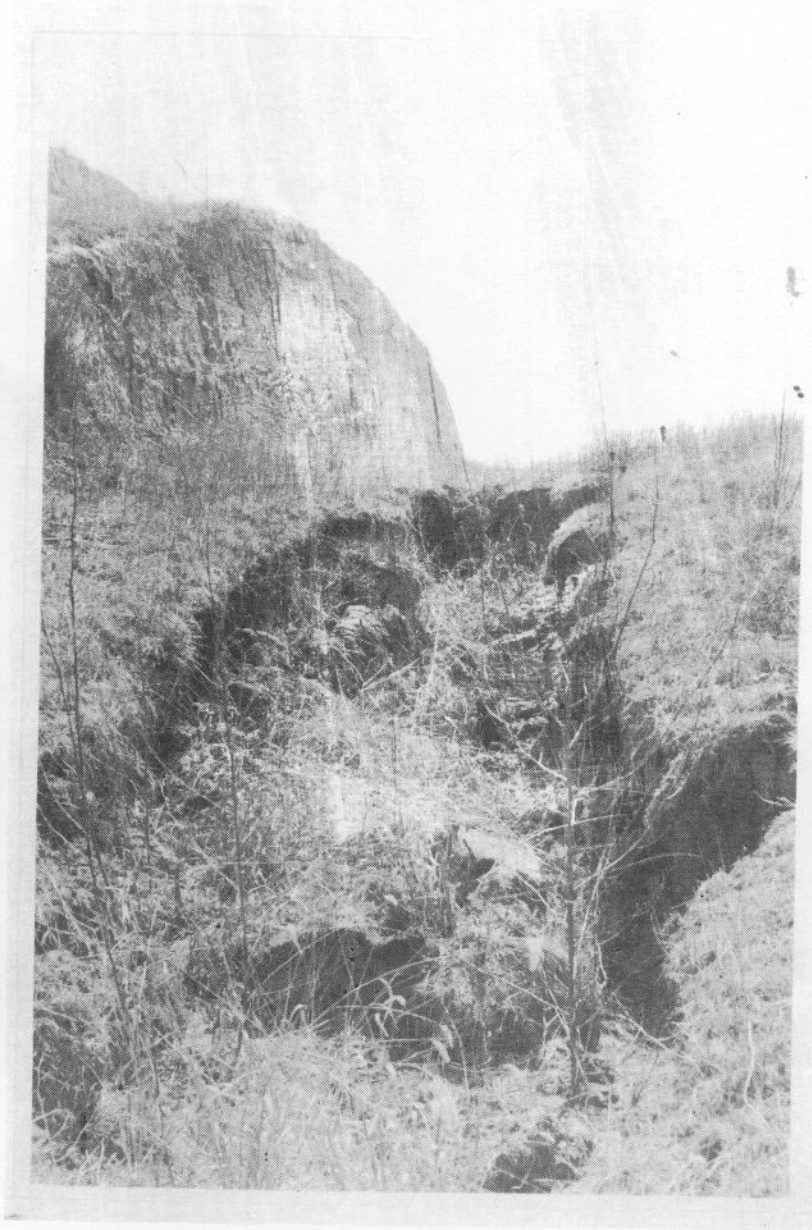
Figure 10. Collapse and erosion due to excessive water concentration at the end of a sodded V-shaped bench (Holt County, Route I-29)

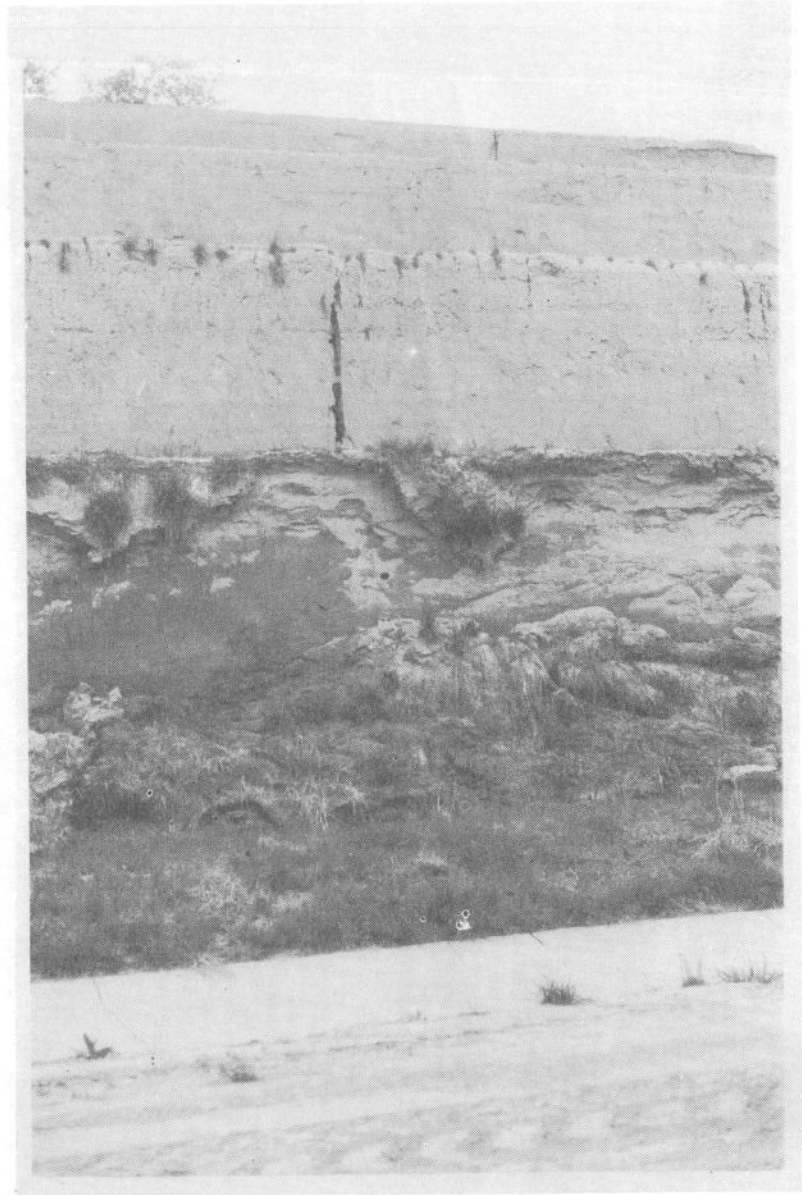
Figure 11. Slope damage due to persistent seepage from a truncated water table. Piping outlets in the face above are also evident (Holt County, Route I-29)

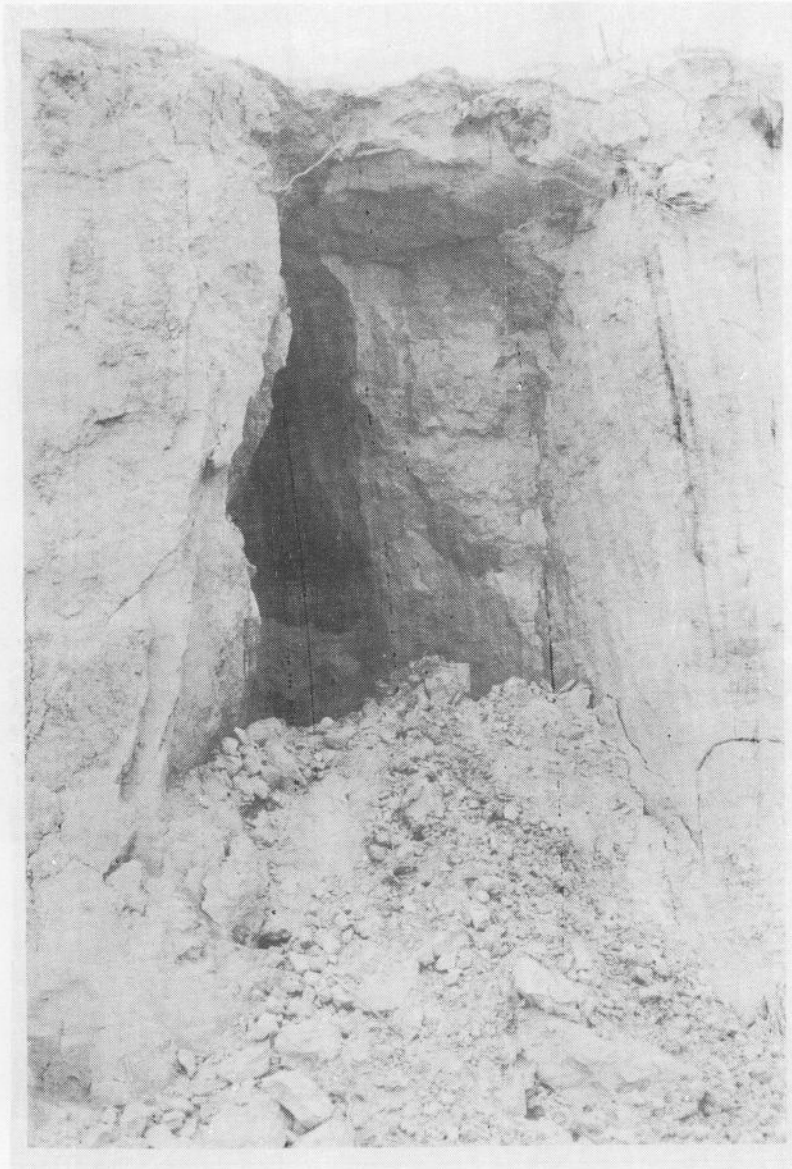
Figure 12. Piping damage to a vertical face
(Holt County, Route I-29)

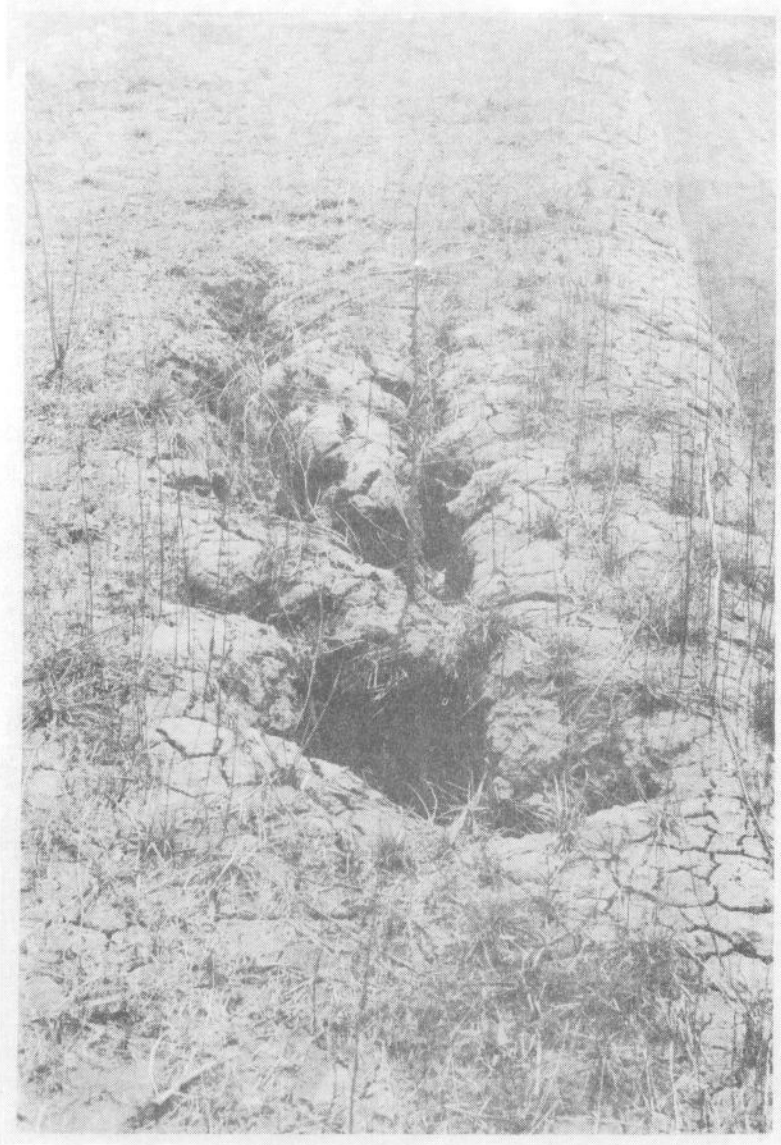
Figure 13. Piping inlets on a bench originating from frost damage (Holt County, Route I-29)

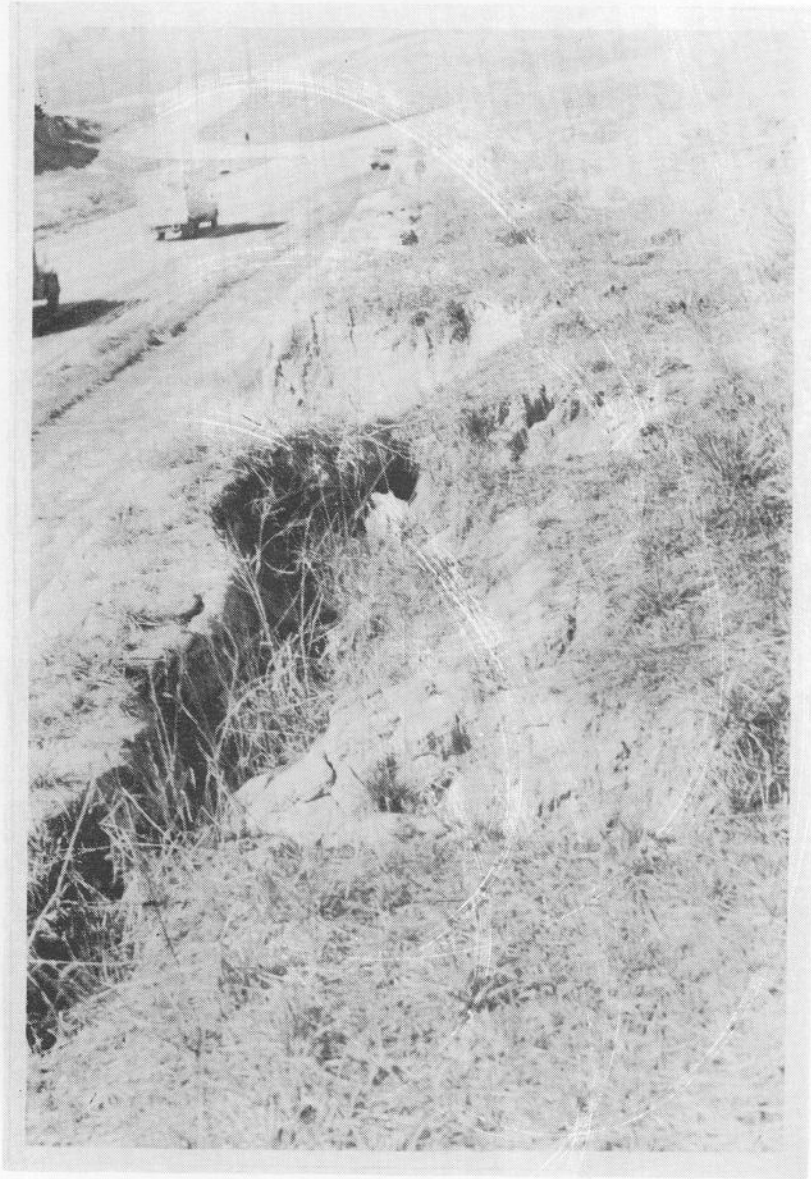
Figure 14. Bench erosion following frost damage (Atchison County, Route 136)

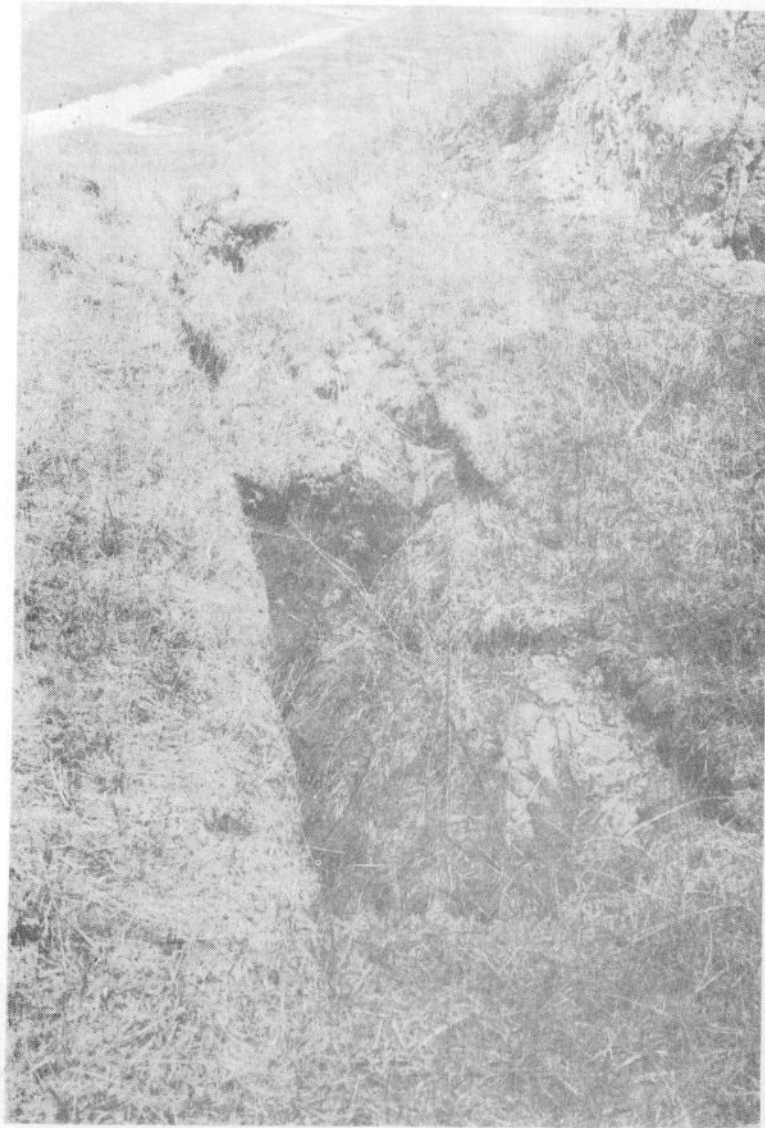
Figure 15. Piping damage and progressive erosion due to insufficient bench gradient (Holt County, Route I-29)

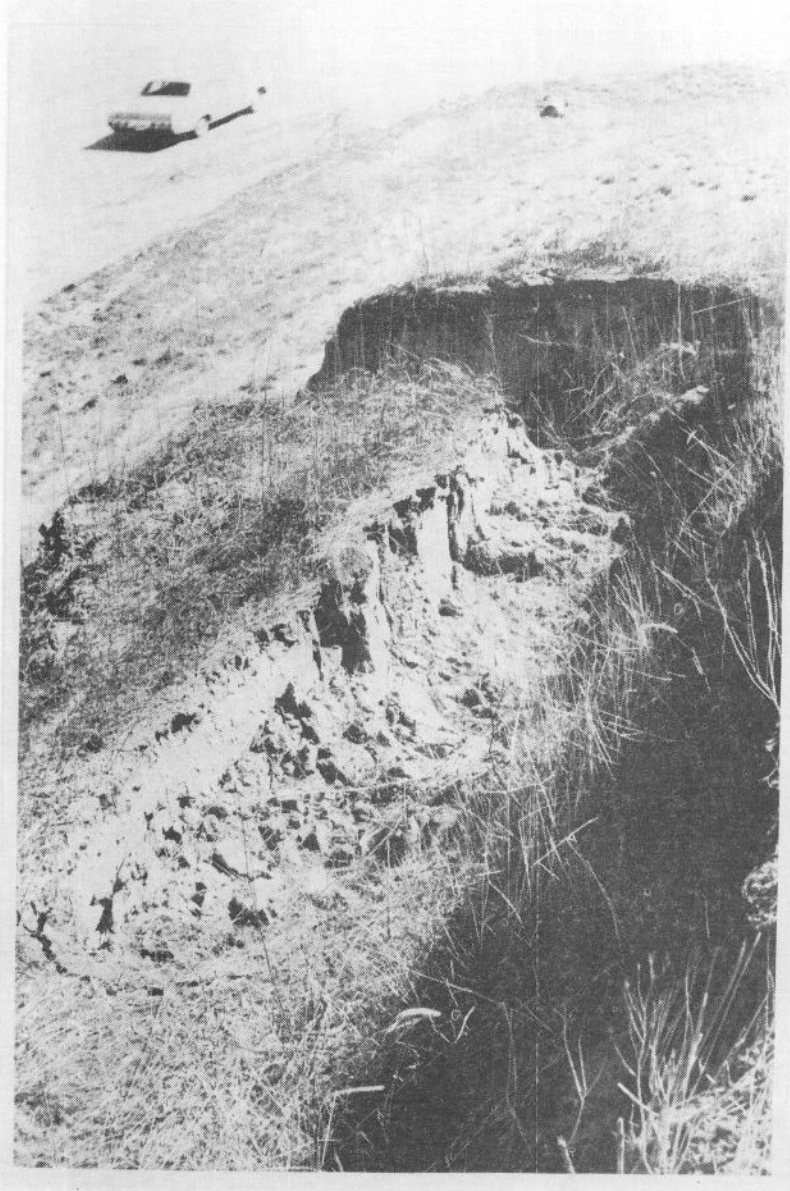
Figure 16. Collapse failure progressing in a sodded bench (Atchison County, Route 136)

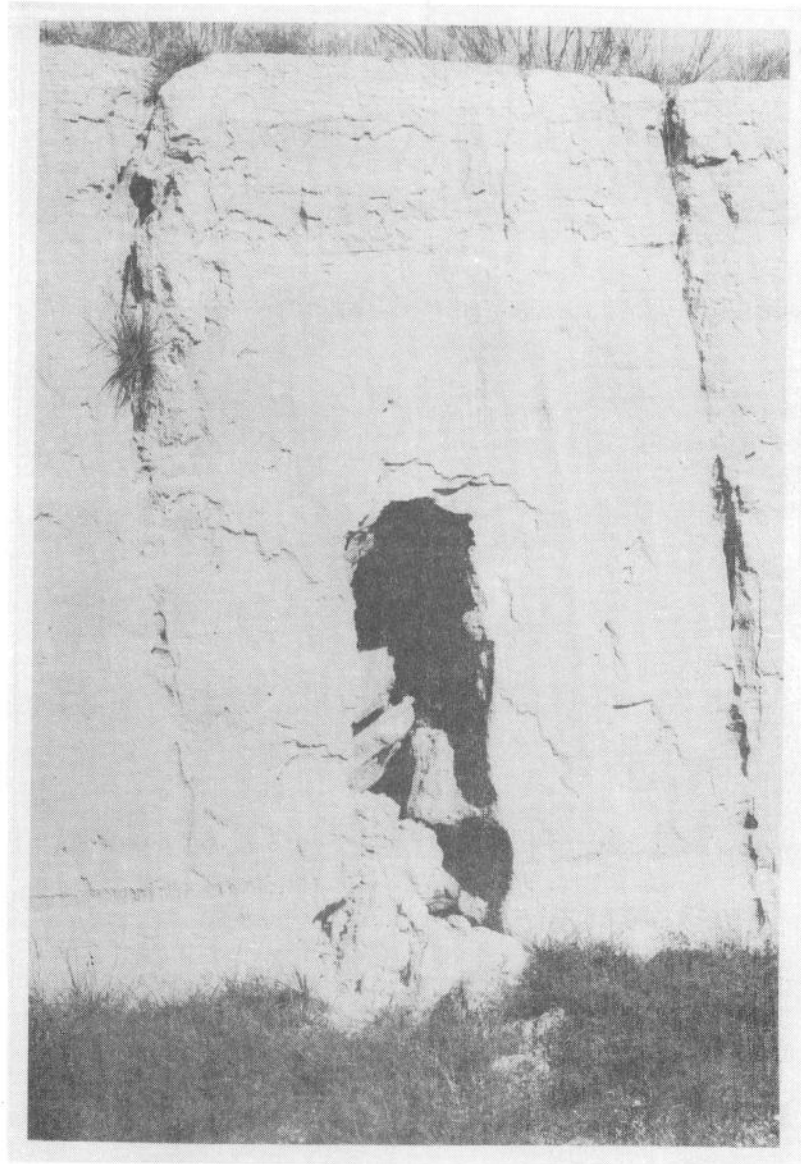
Figure 17. Piping outlet in a near vertical face
(Holt County, Route I-29)

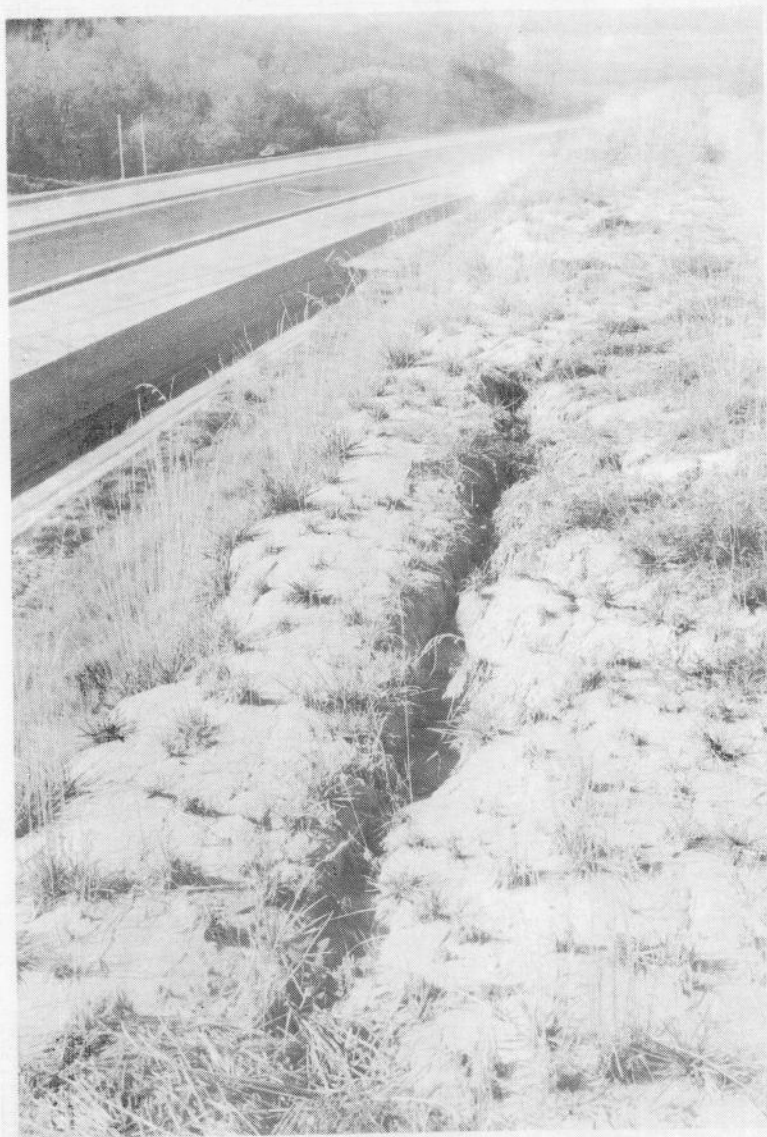
Figure 18. Piping inlets above the face shown in Figure 17 (Holt County, Route I-29)

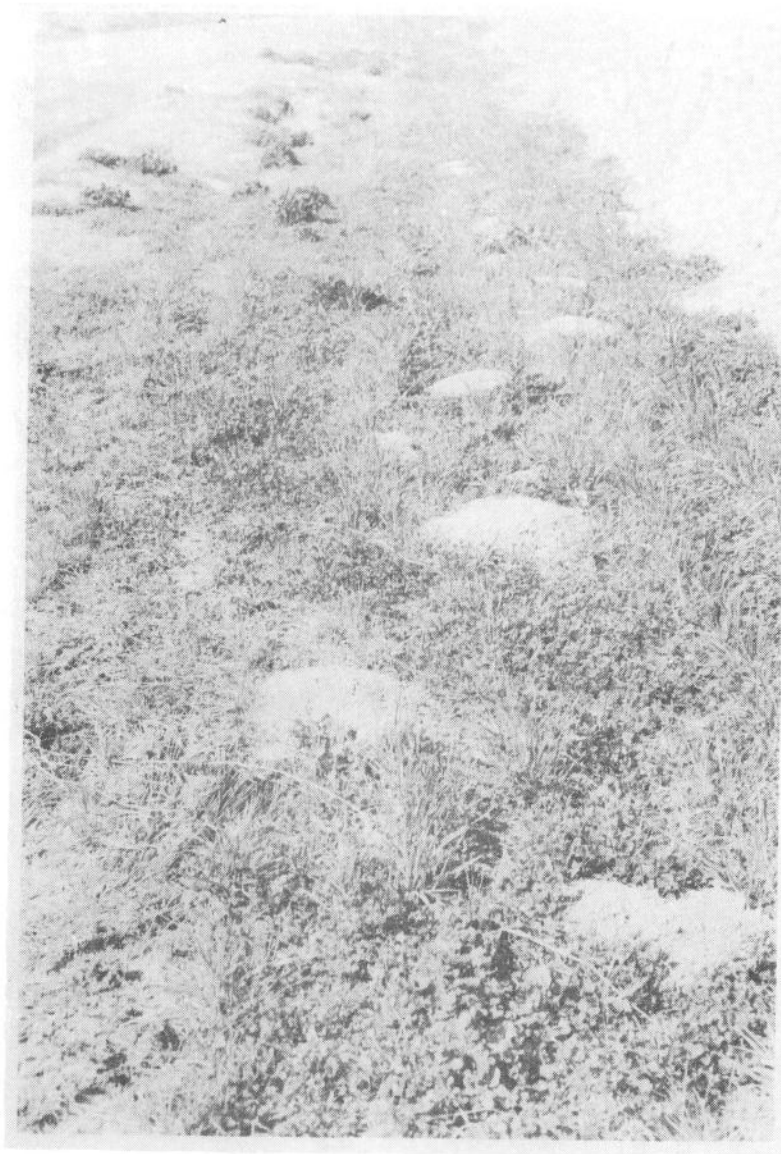
Figure 19. Rodent damage on a bench which can cause piping (Atchison County, Route 136)

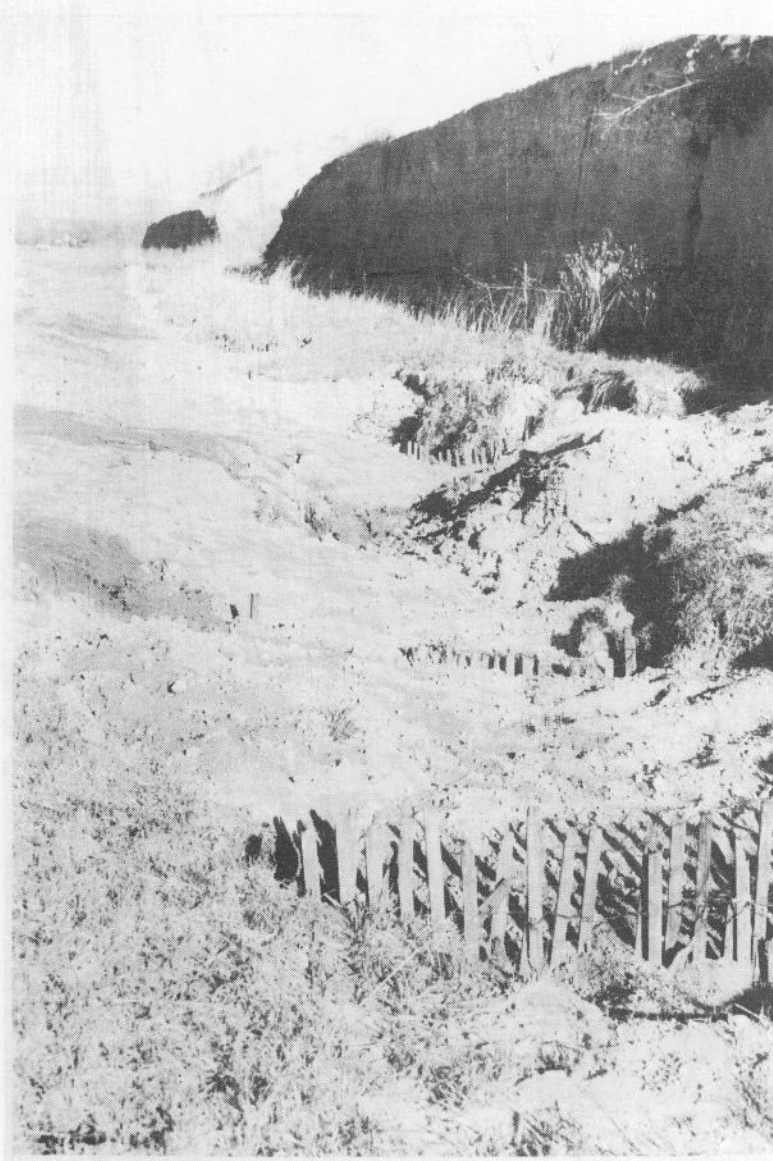
Figure 20. An attempt to control ditch erosion by catching siltation from erosion of the cut slopes (Holt County, Route F(159))

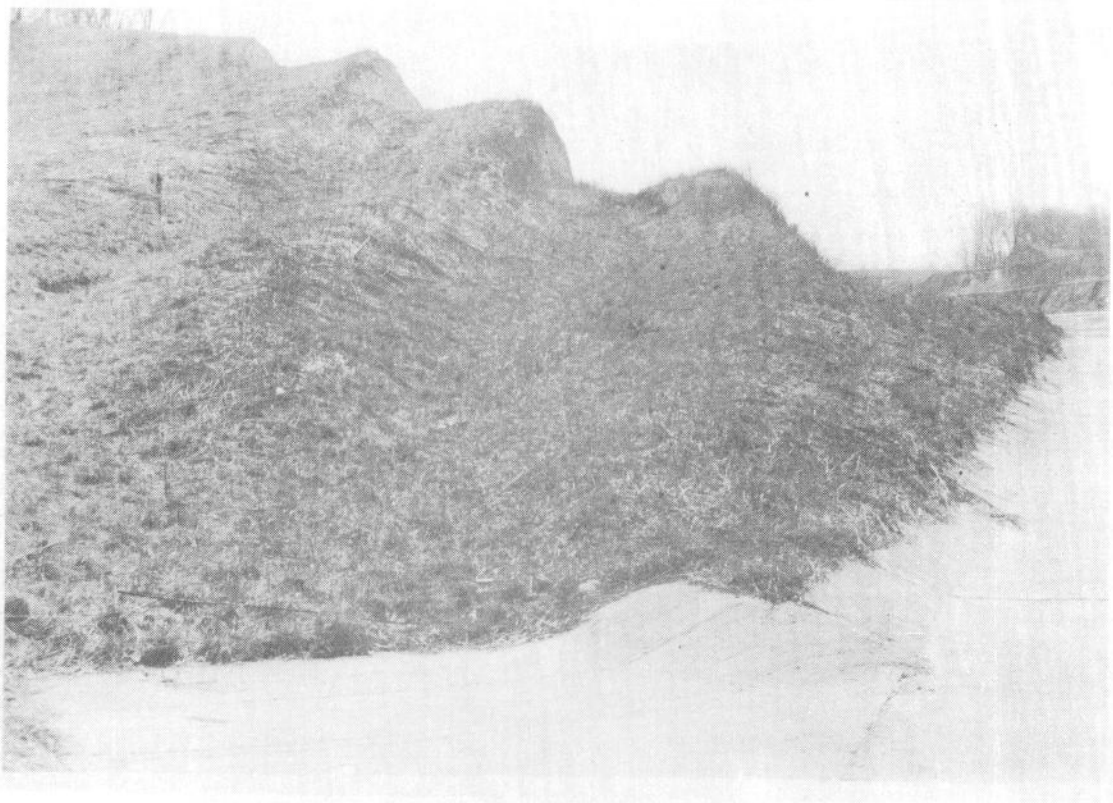
Figure 21. Erosion on a sodded V-shaped bench (Holt County, Route I-29)

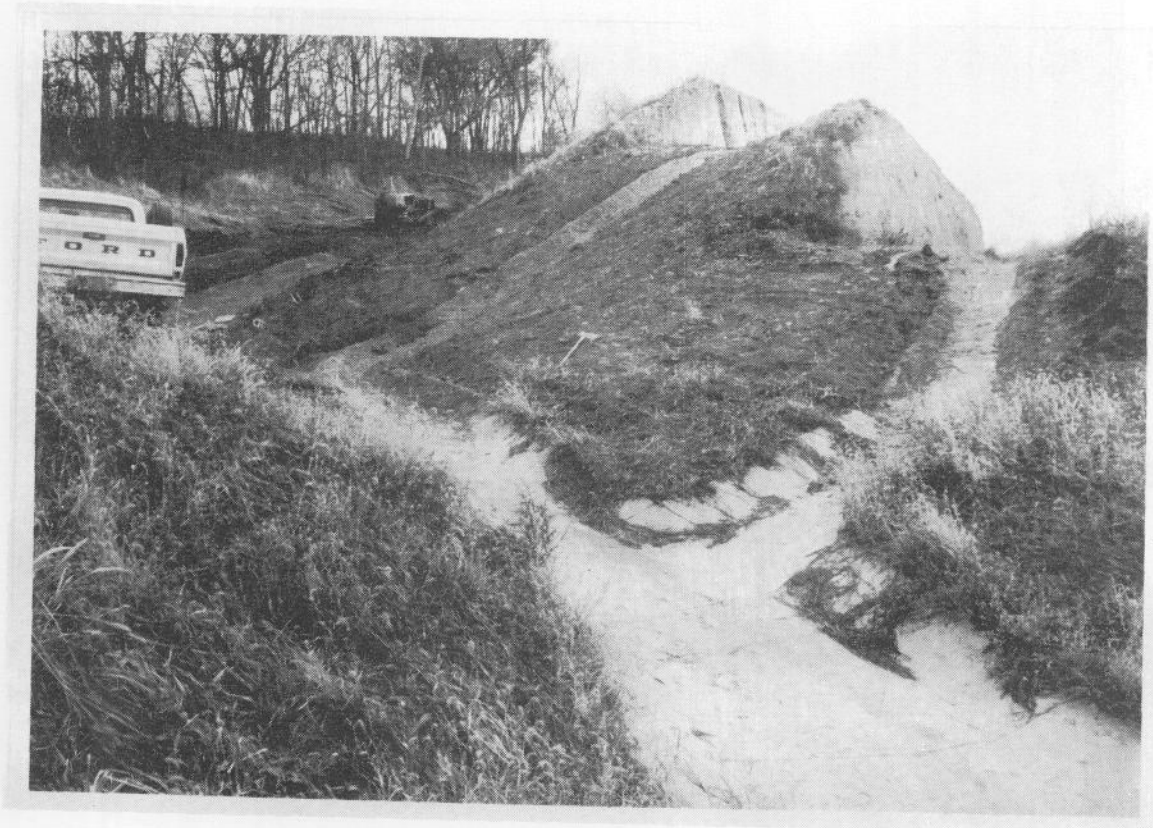
Figure 22. Extensions on paved ditches to control bench erosion (Holt County, Route I-29)

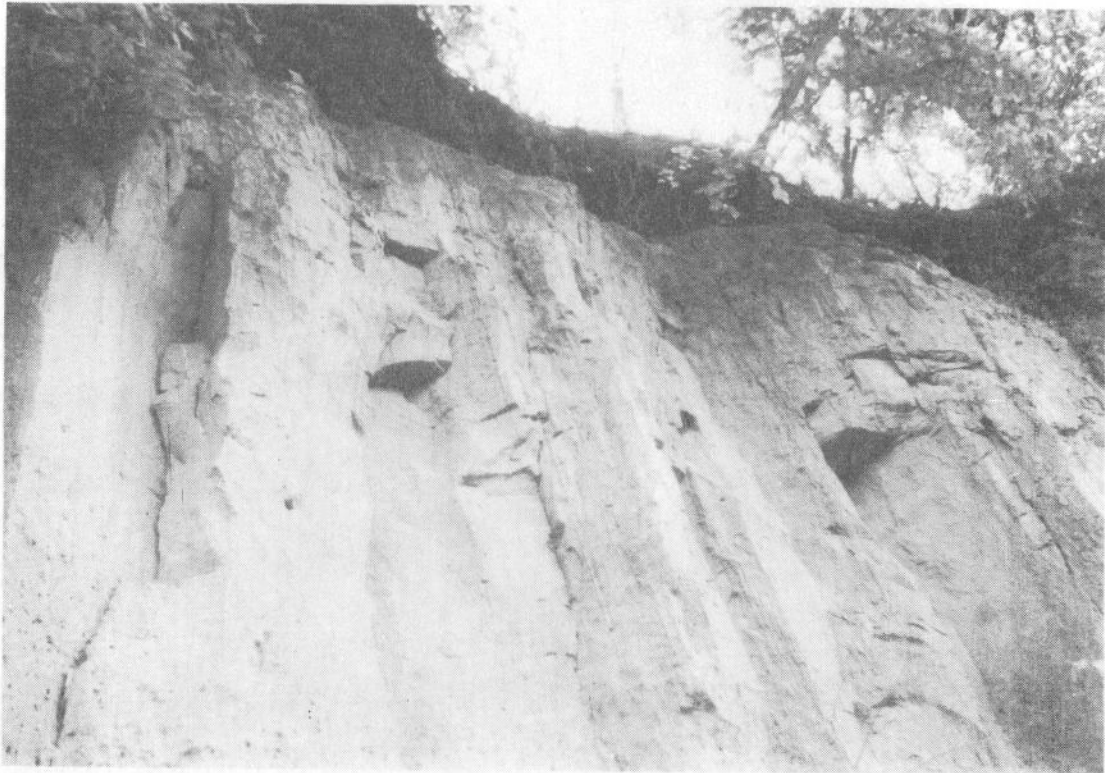
Blocks and slabs of hard soil often fall from vertical faces of loess due to shrinkage cracks developing from volume change. With shrinkage potential a function of clay content, density, and moisture, most failures occur shortly after faces of wet, "clayey" loess are first exposed to drying. Typical pictures of volume change effects are shown as Figures 23 and 24.

Figure 23. Slabbing occurring along natural joints in loess (Boone County, Route 40)

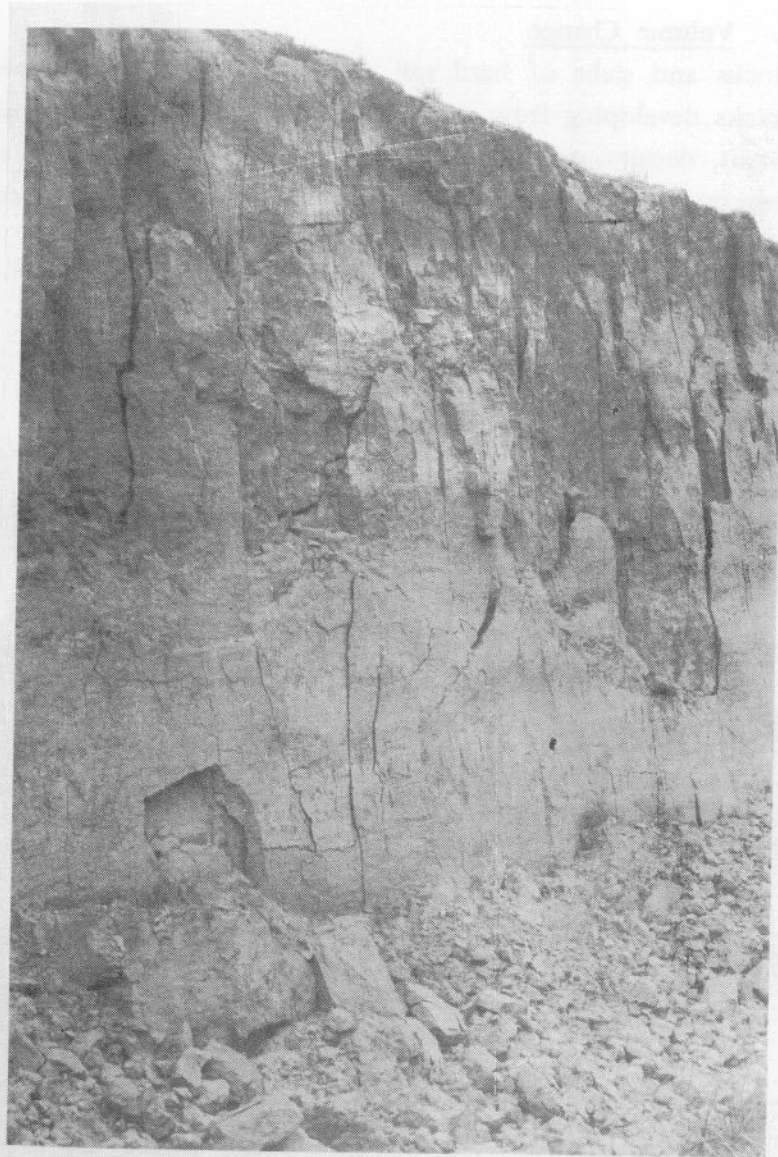
Figure 24. Shrinkage cracks in "clayey"
loess (Clay County, Route 210)

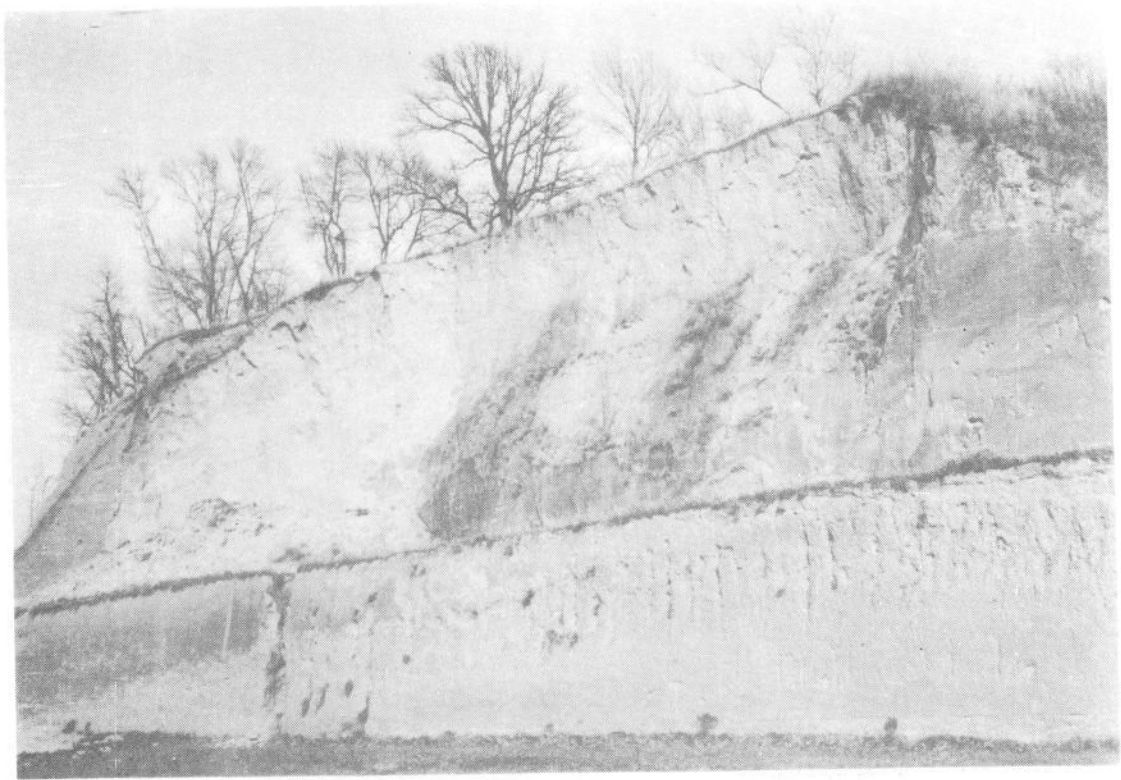
Slides usually follow a parabolic or semi-circular failure arc in loess. A slide failure of a 50 foot near vertical (1/4:1) slope is shown in Figure 25. A schematic of typical slide failure, with the characteristic steep scarp and large slump berm is shown as Figure 26.

Figure 25. A slide in a 50 foot near vertical face (Atchison County, Route 136)

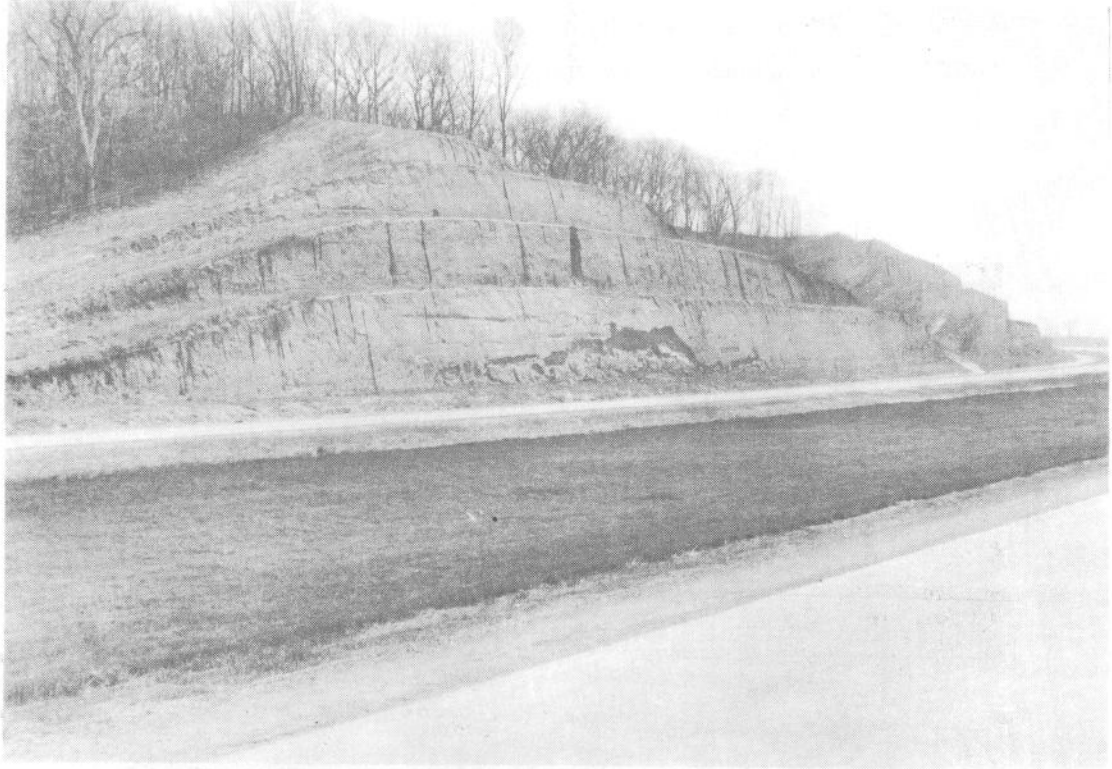
This is a progressive type of distress originating as a local slough near the base of a vertical slope. It effectively steepens the slope, sometimes establishing an overhang, and eventually contributes to a stability failure. It is most frequently found where a vertical rise truncates a water table or a stratum having very low cohesive strength (as a sand lense) or excessive moisture content. A typical example which will probably progress to slope failure is shown in Figure 27.

Figure 27. Slope damage due to a truncated water table
(Holt County, Route I-29)

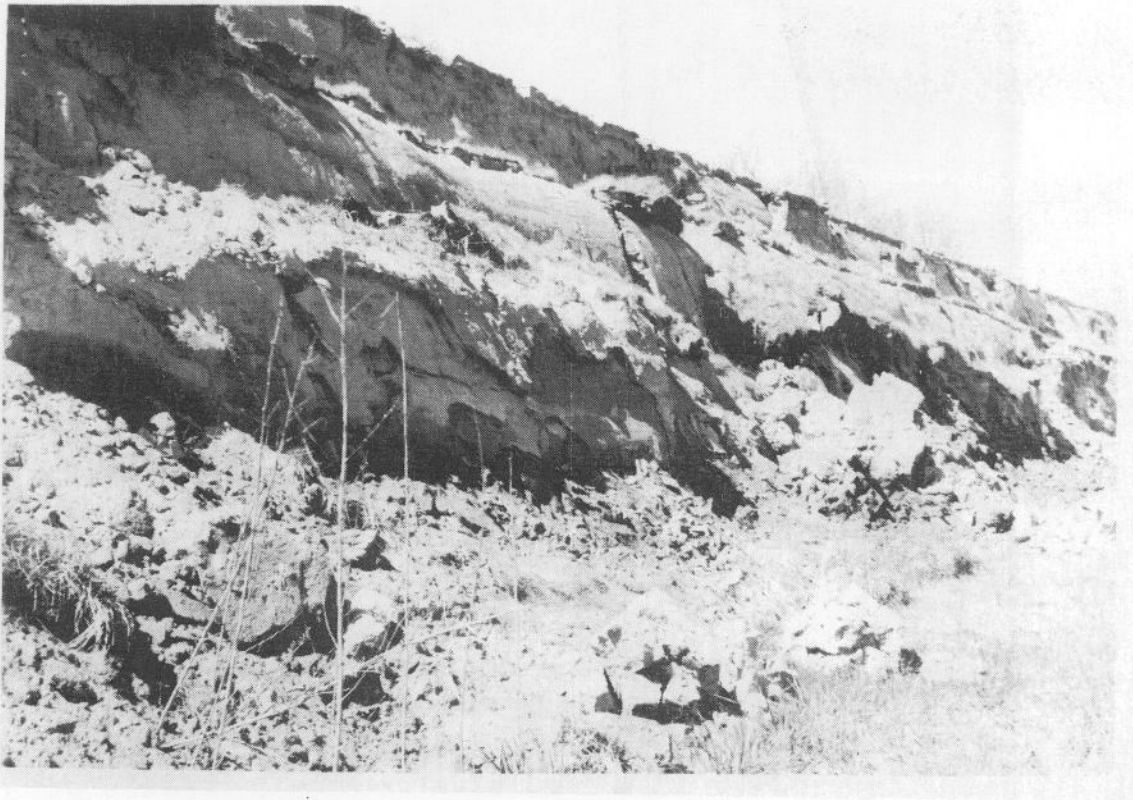
Figure 28. Stepped slope approaching an effective 1.5 to 1 with degradation by erosion and slides (Holt County, Route I-29)

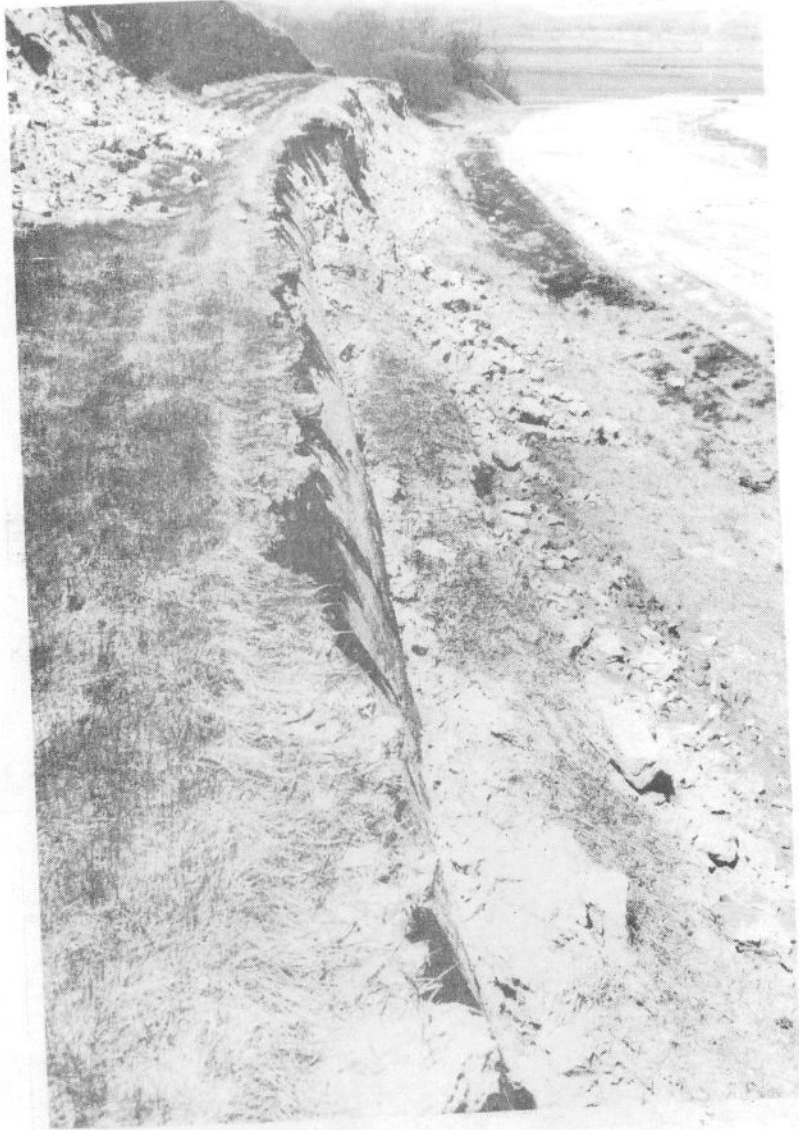
Figure 29. Slump blocks resulting from frost damage are evident on this north facing slope (Holt County, Route I-29)
