MISSOURI COOPERATIVE HIGHWAY RESEARCH PROGRAM
FINAL REPORT

74-1

**DEVELOPMENT OF DESIGN CRITERIA
FOR CUT SLOPES IN LOESS**

MISSOURI STATE HIGHWAY DEPARTMENT

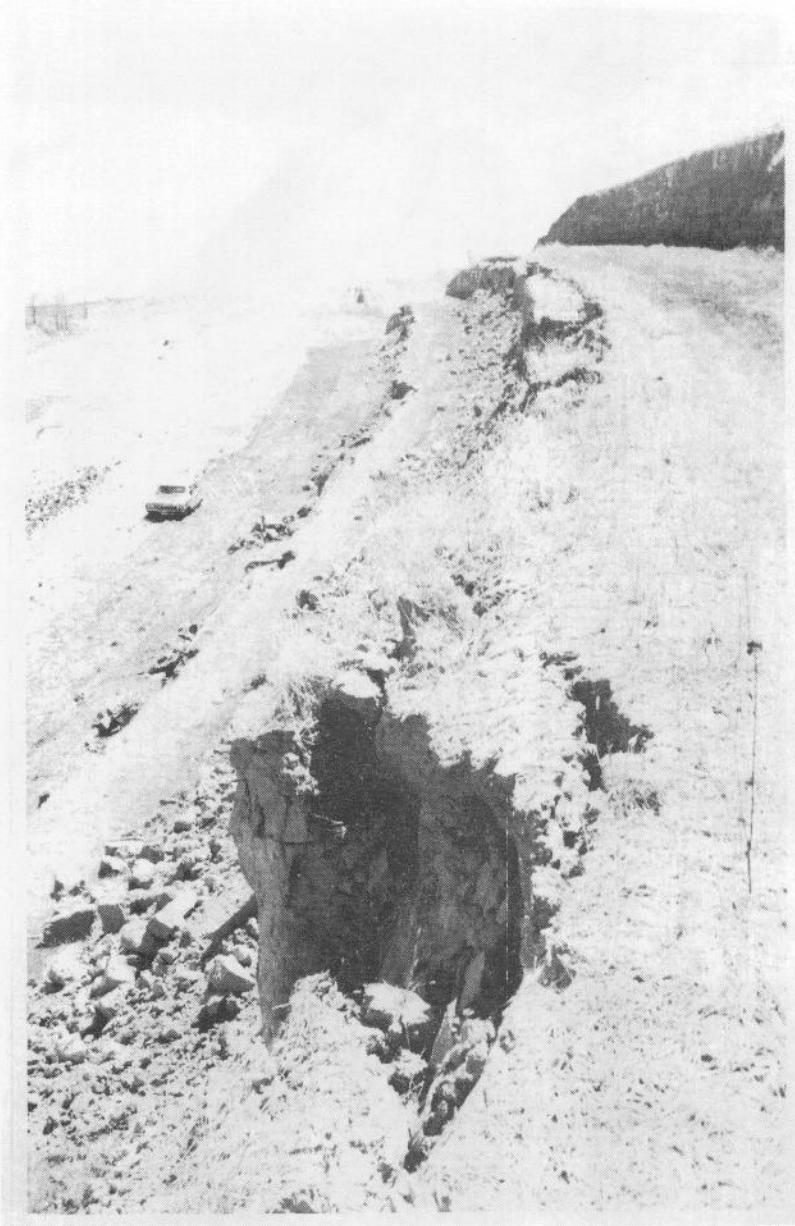
Figure 30. Failure plane from ice lense development is evident on this north facing slope (Holt County, Route I-29)

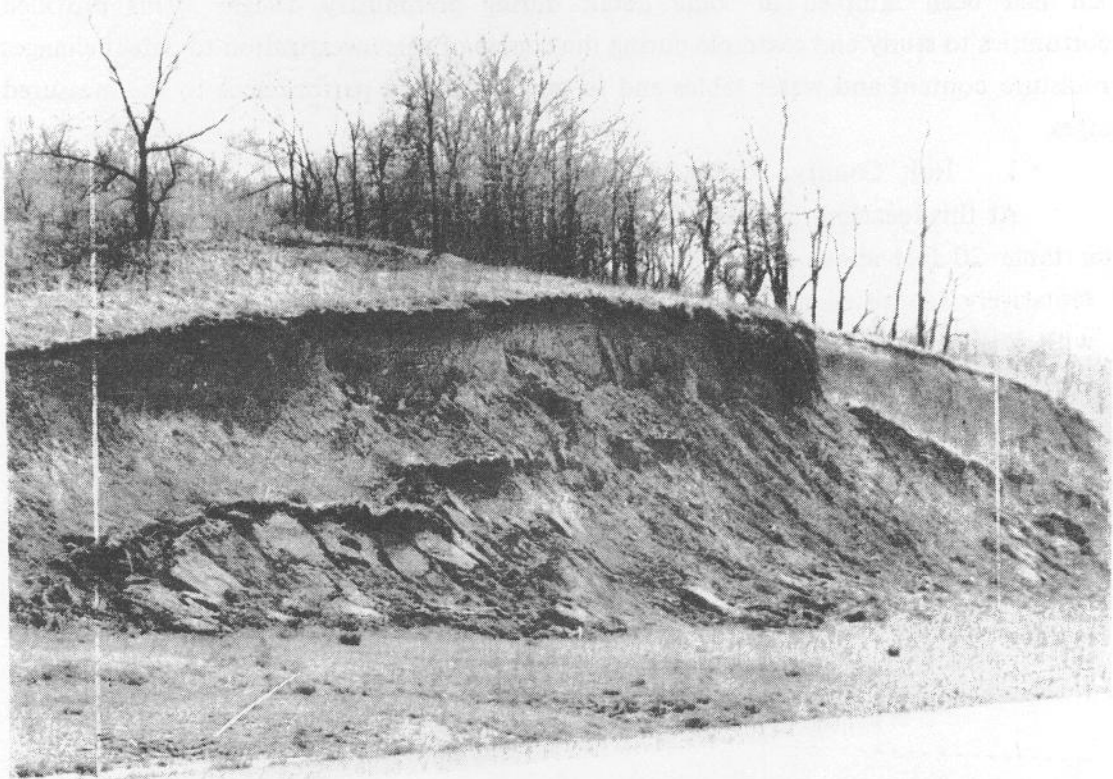
Figure 31. Frost damage to a vertical slope
(Clay County, Route 210)
