MISSOURI COOPERATIVE HIGHWAY RESEARCH PROGRAM
FINAL REPORT

74-1

**DEVELOPMENT OF DESIGN CRITERIA
FOR CUT SLOPES IN LOESS**

MISSOURI STATE HIGHWAY DEPARTMENT

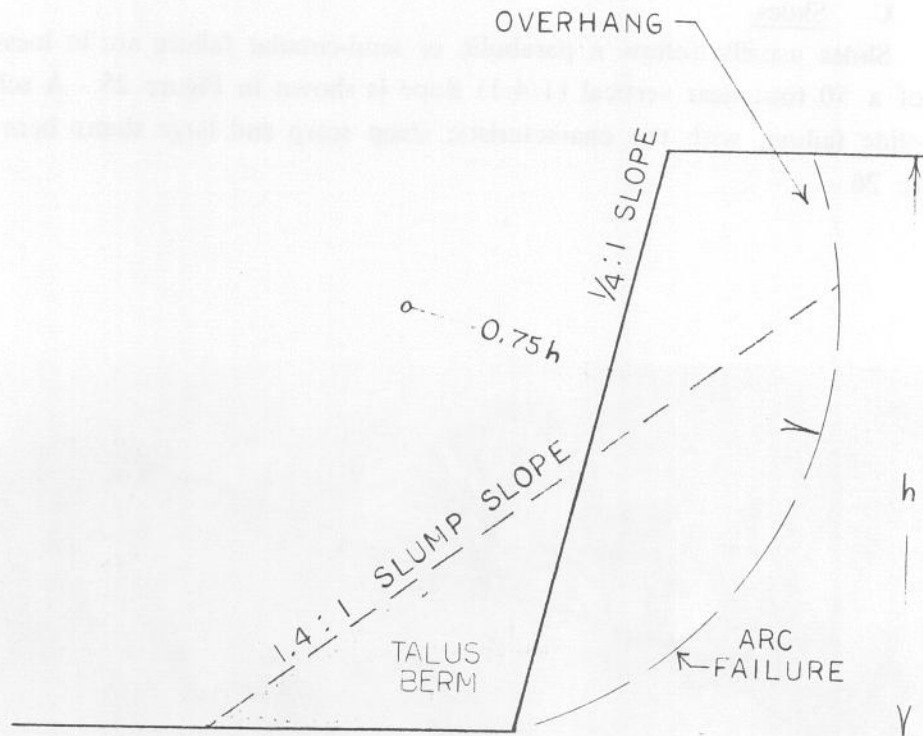
Figure 26. Schematic of a slide failure surface in a near vertical slope

Slides usually follow a parabolic or semi-circular failure arc in loess. A slide failure of a 50 foot near vertical (1/4:1) slope is shown in Figure 25. A schematic of typical slide failure, with the characteristic steep scarp and large slump berm is shown as Figure 26.

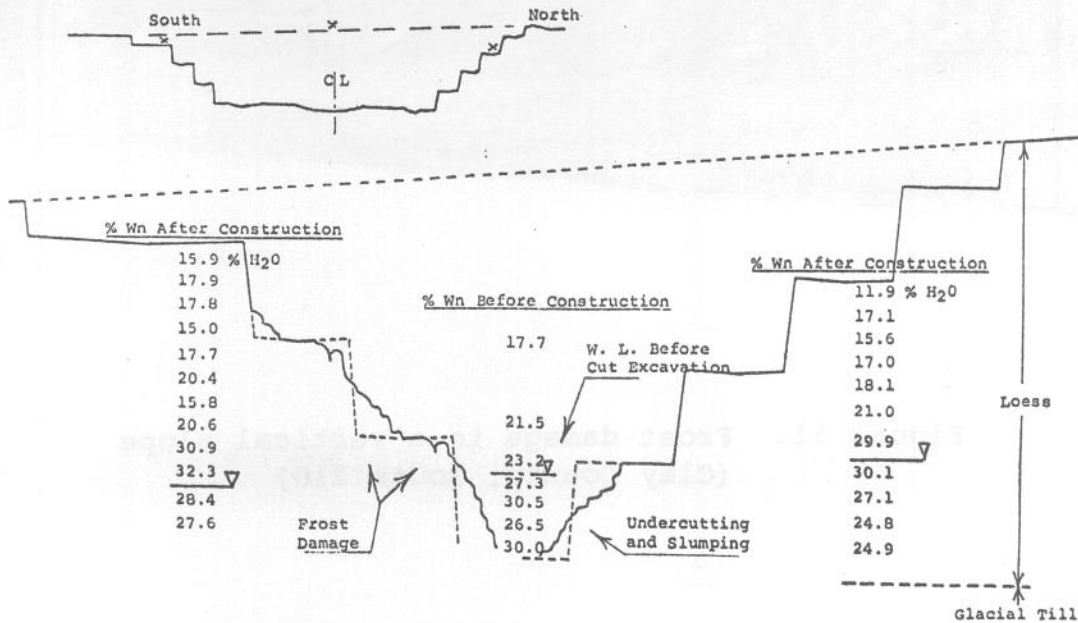
Figure 32. Comparison of moistures before and after construction at Station 1000, Holt County, Route I-29.

At this location, 86 feet of loess was found overlying glacial till with an original water table 20 feet above the till contact (see Figure 32). The loess strata intercepted are tentatively identified as Bignell, Peoria and Roxana with pockets of fine sand and silt with low cementation near the base of the cut (Loveland).

The roadway is oriented northwest to southeast with grade just above the till contact and about 18 feet below the original water table. Preconstruction moisture contents in the loess averaged about 17 percent above the water table and 28 percent below. The planned design for this area called for 20 foot wide, sodded V-shaped benches and nearly vertical rises (1/4:1) to a maximum of 20 foot height. Five rises were used on the southwest facing slope and four on the northeast facing slope. A basic design assumption was that pilot trenching of the cut would lower permanent water levels and reduce the high moisture content of the loess below the original water table.

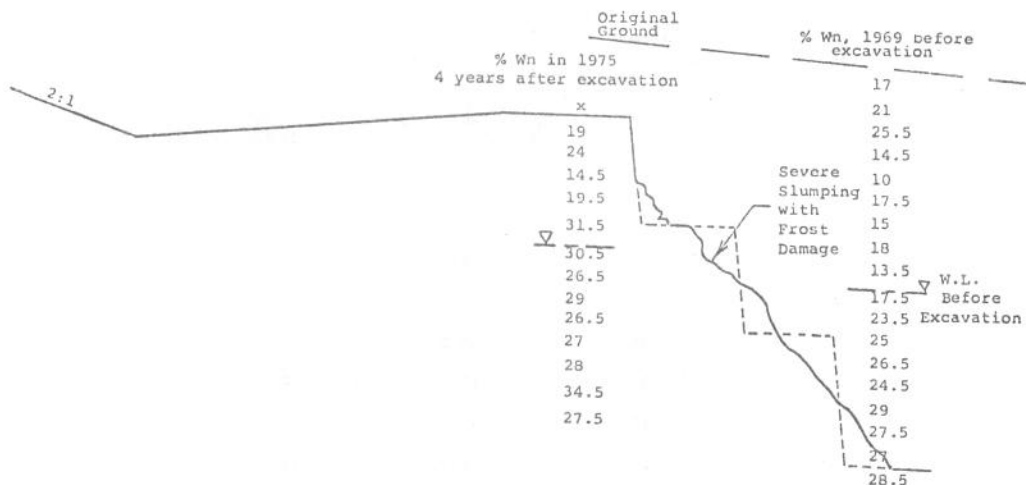
Figure 33. Comparison of moistures before and after construction at Station 23, Howard County, Route D(87).

This north-south oriented, 90 foot deep cut is on the south bank of Greggs Creek immediately east of the Missouri River. Original sampling at this location revealed a high water table with moisture contents averaging slightly less than 17 percent above the water table and 26.2 below. The cut was designed with 5 near vertical rises of 1 on 10 to 20 foot height with 15 foot wide sodded benches. The original water table was found at an elevation corresponding to the first bench at the toe of the second 20 foot rise (see Figure 33).

Erosional losses on the project led to extensive borrowing of soil from the top of the slope so that the original design was extensively modified, resulting in only three rises of 20 foot height with a 2 1/2 to 1 slope of 27 feet height at the top of the slope behind a flat bench approximately 100 feet wide.

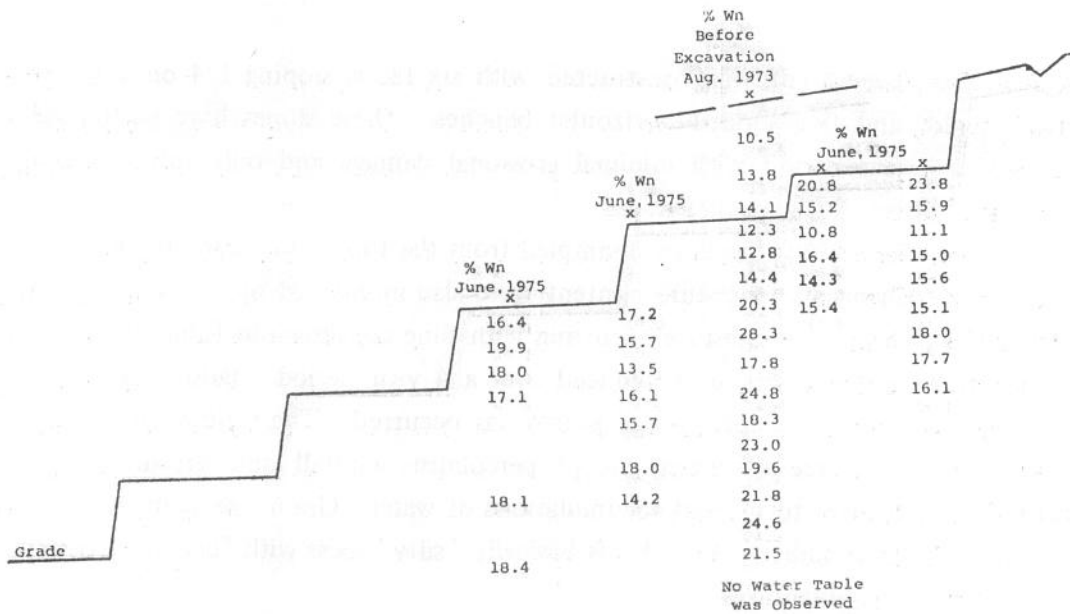
Figure 34. Comparison of moistures before and after construction at Station 131, Buchanan County, Route I-229.

All of these cuts were sampled prior to excavation and no permanent water table was found. The results of all of the soundings were similar. Data from one of the cuts in the vicinity of station 131 is included as Table 16. Moisture contents averaged about 17 percent and the loess was found to overlie sand and gravel of glacial outwash origin (see Figure 34)

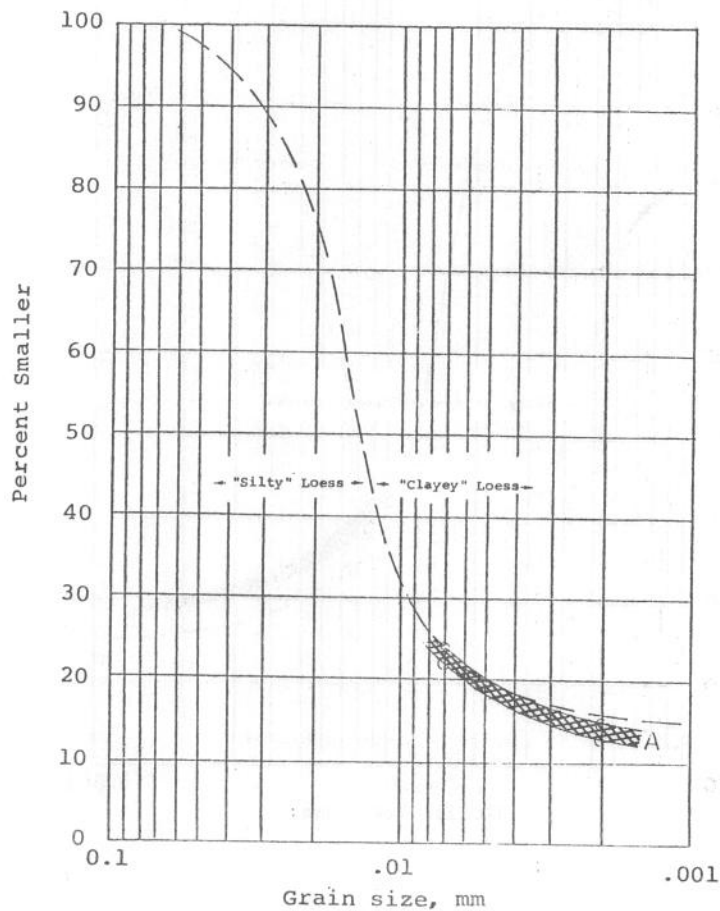
The five types of slope distress, as defined in the section entitled "Performance Survey", are related to the "silty" and "clayey" gradation bands in Figures 35 through 39. Figure 35 indicates the range of grain sizes found for samples obtained from slopes with erosion as a primary problem. The cross hatched area marked A indicates that, as would be expected, these curves fall in the "silty" loess range. These are mostly ML soils with an average liquid limit of 31.

Figure 35. Samples obtained from loesses having erosion problems have gradation curves which fall within the hatched area.

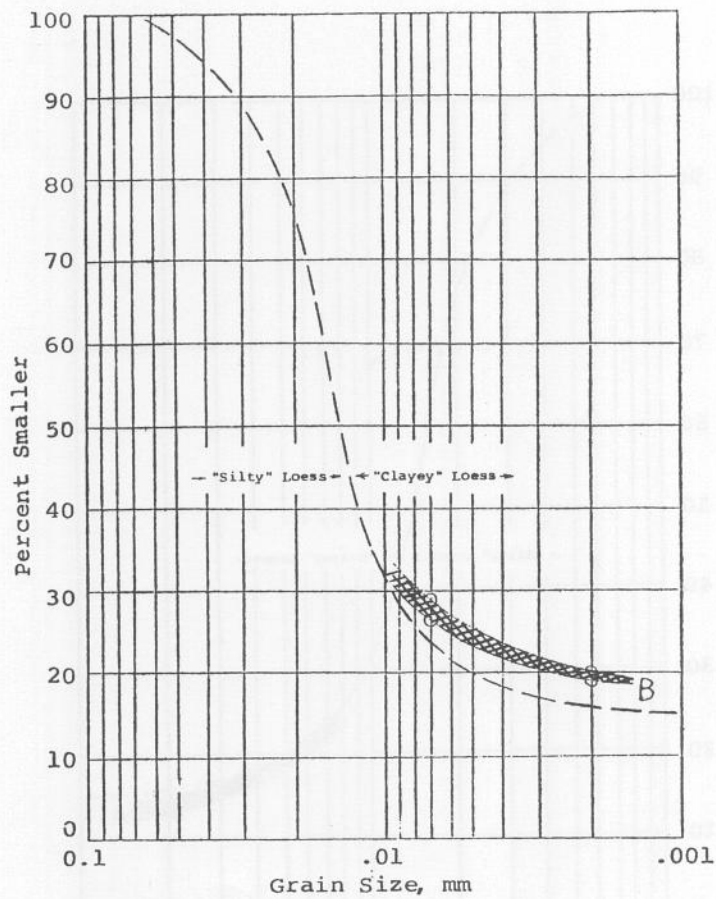
Figure 36 indicates the range of grain size distributions found for samples taken where volume change failures are occurring as sloughing and slabbing. The cross hatched area marked B indicates that these samples fall well in the "clayey" loess range with an average liquid limit of 35.

Figure 36. Samples obtained from loesses having volume change problems have gradation curves which fall within the hatched area.

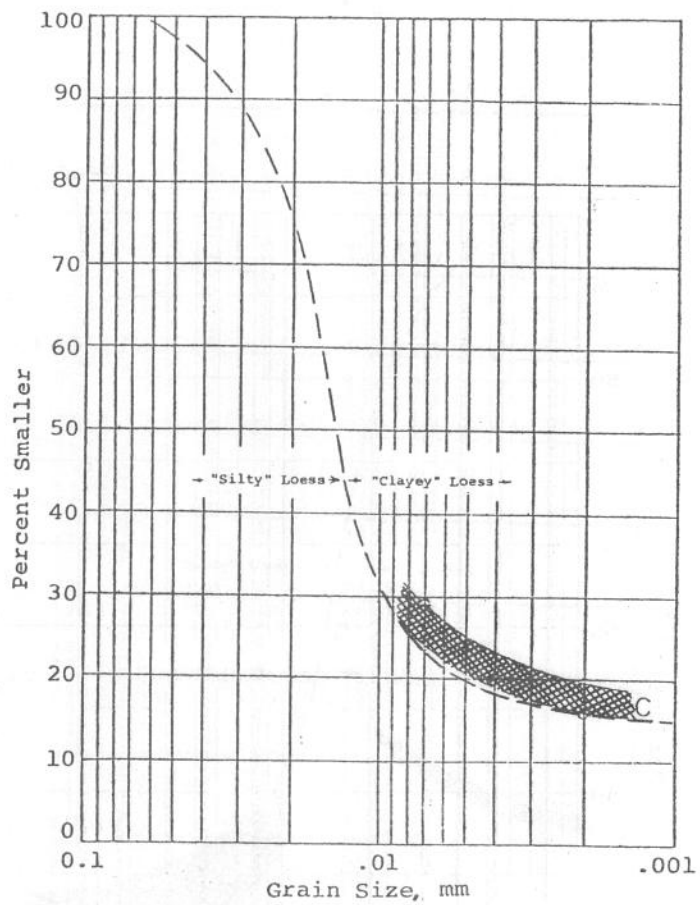
Figure 37 indicates the range of grain size curves for samples taken where slides were found. The cross hatched area marked C falls in the "clayey" range with an average liquid limit of 35.

Figure 37. Samples obtained from loesses in areas of slides have gradation curves which fall within the hatched area.

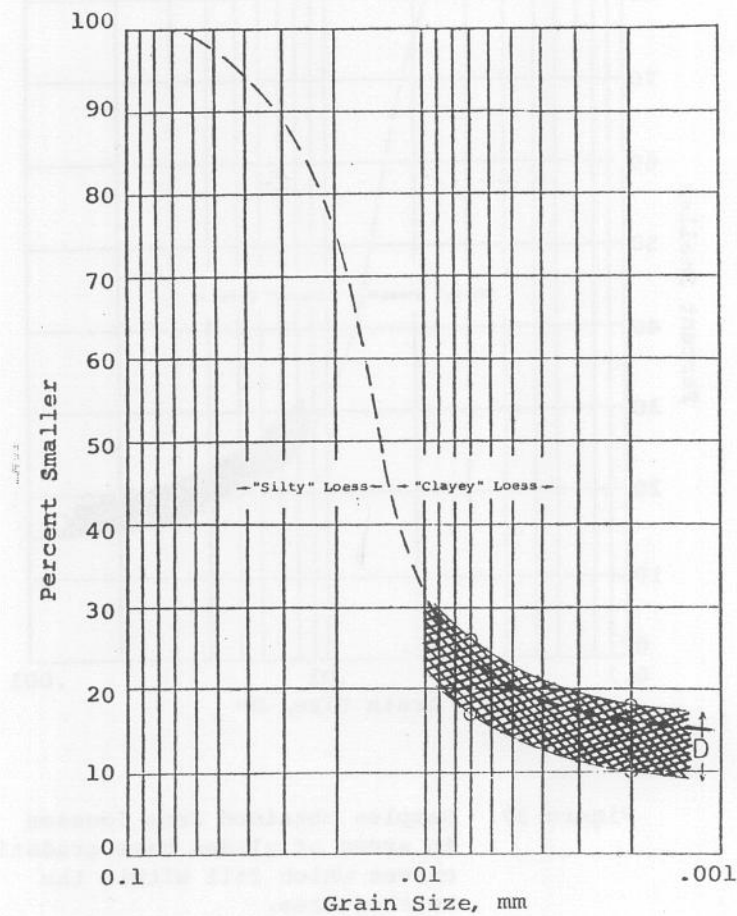
Figure 38 indicates the grain size range for samples taken where undercutting was occurring. The cross hatched area marked D indicates grain size curves to vary from "silty" to "clayey" in range. The corresponding liquid limit range is 31 to 34. This seems reasonable as the local failures which comprise this category are most often a consequence of high moisture contents, included truncated water tables, which cause problems in either category of loess when vertical slopes are used.

Figure 38. Samples obtained from loesses where undercutting is occurring have gradation curves which fall within the hatched area.

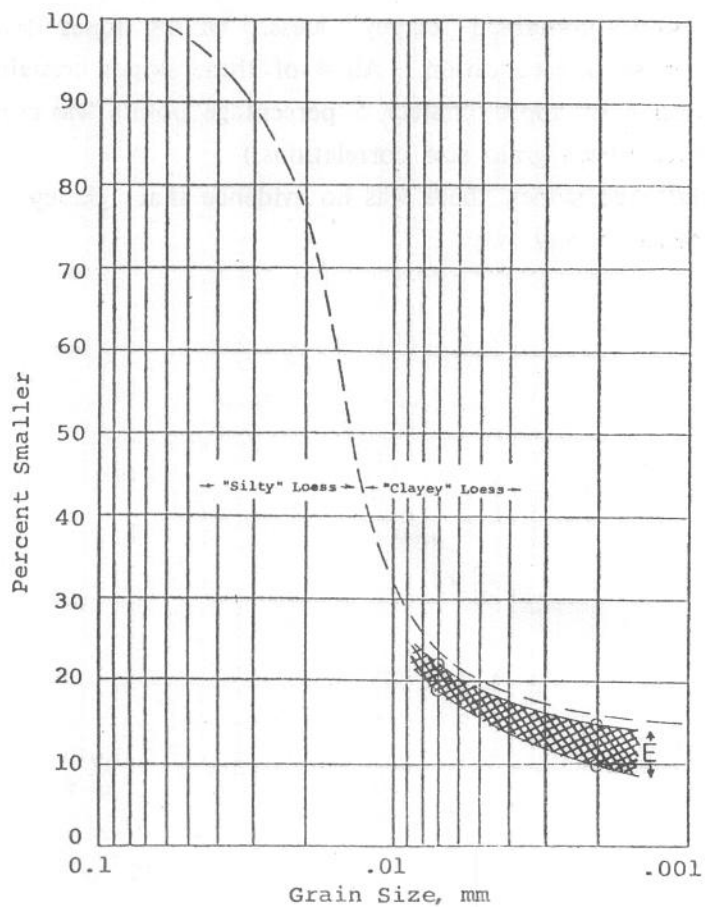
Figure 39 indicates the grain size range of samples secured in areas where frost damage was evident. The cross hatched area marked E indicates the "silty" loess soil normally identified with this type of failure.

Figure 39. Samples obtained from loesses where frost damage has occurred have gradation curves which fall within the hatched area.
